ICFDP7-2001061

NEW TURBOMACHINERY HOUSING DEVELOPMENT

Honeywell International Inc.

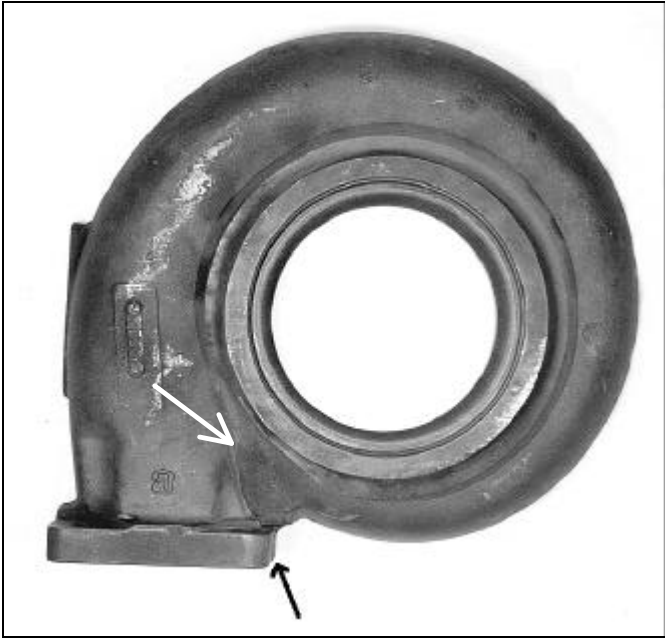
Figure 1: Volute Crack on A Hosing Subjected to Aggressive Field Duty Cycle

The issues of concern in this paper are the external cracks. In particular, the external cracks at the foot of the turbine inlet flange and at the volute near the V-band location. The volute cracks near the V-band typically initiate close to volute-to-flange connection and propagate circumferentially parallel to the flow (Figure 1). The inlet flange cracks typically initiate from the volute entry on the inlet flange (Figure 2).

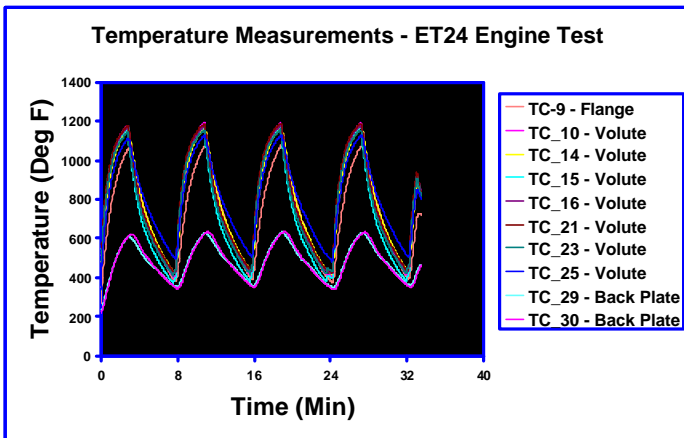
Figure 5: Skin Temperature Profile on Turbine Housing and Back Plate on Accelerated Engine Thermal Cycle.

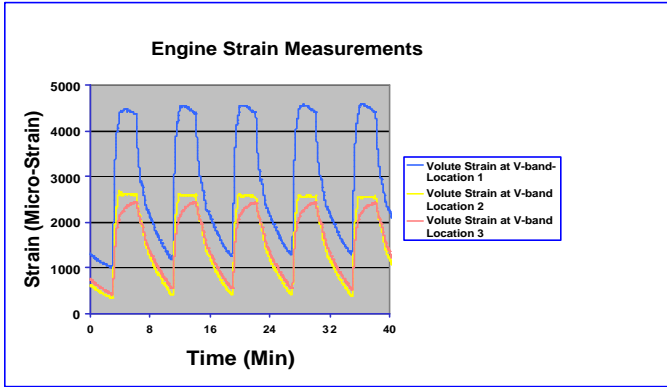
Figure 7 shows the quasi-static strain levels for 5 consecutive cycles. The cycles are repeatable and the trends are logical and follow what one should expect from such thermal cycles. Results indicate high strain levels at the V-band locations with the highest value around 4500 micro-strain at gauge 1 location. This location is on the volute, near the volute-to-flange connection. These high values indicate that the material has yielded at these locations (yield for this material is defined as .2% yield). For accurate life predictions at these locations plasticity and creep should be included (Reference 11 and 12).

Figure 7: Quasi-Static Strain Profile During Accelerated Engine Thermal Cycle.

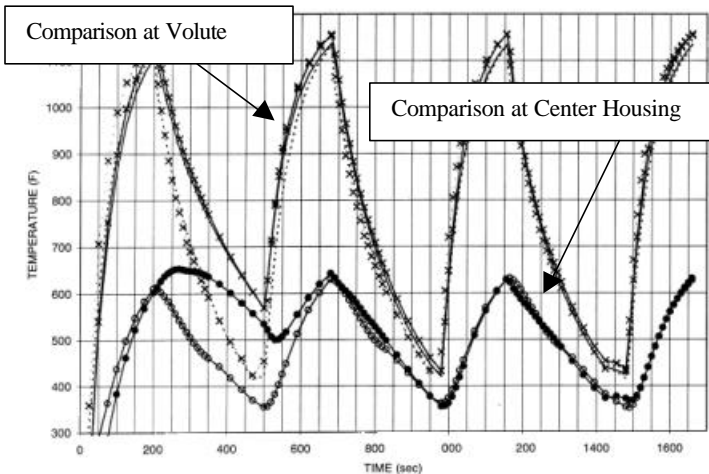
- Experimental Data at Volute-Location 1
- x----- Experimental Data at Volute- Location 2
- o— Experimental Data at Center Housing
- Analytical prediction at Volute-Location 1
- x— Analytical prediction at Volute-Location 2
- Analytical prediction at Center Housing

Figure 10: Comparison of Thermal Transient Model with Measured Temperatures on the Engine.

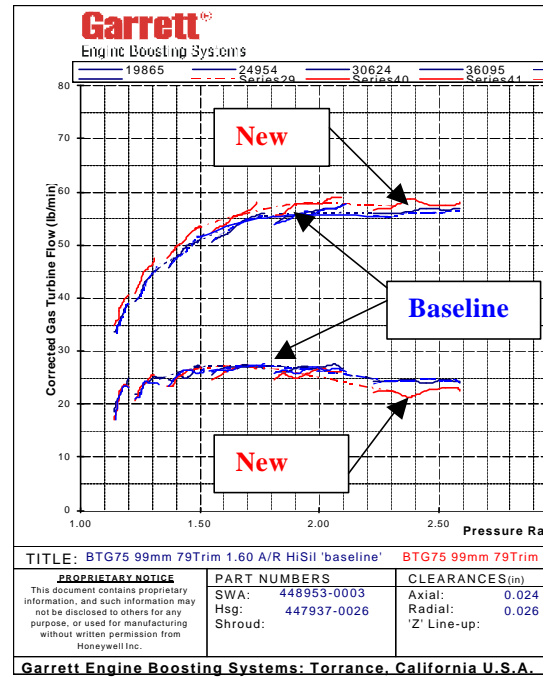
Turbine housing maps for the new turbine design and the baseline design were compared in Figure 18. The comparison indicates that the maps are close to identical at lower pressure ratios. They start to deviate at higher-pressure ratios around 2. The deviation builds up as the new design exhibit lower efficiency around 1-1.5 points difference at about pressure ratio of 3. However, after close examination of the data, it was discovered that the slightly lower efficiency is attributed to slightly higher A/R (A parameter used to indicate the relative size of a turbine housing) for the new design. The pivoting of the efficiency curves is an indication of slight A/R variation between the two housings. This suggests that A/R can be modified to obtain the performance characteristic close to the baseline design.

Figure 18: Turbine Map Comparison between Housing Design

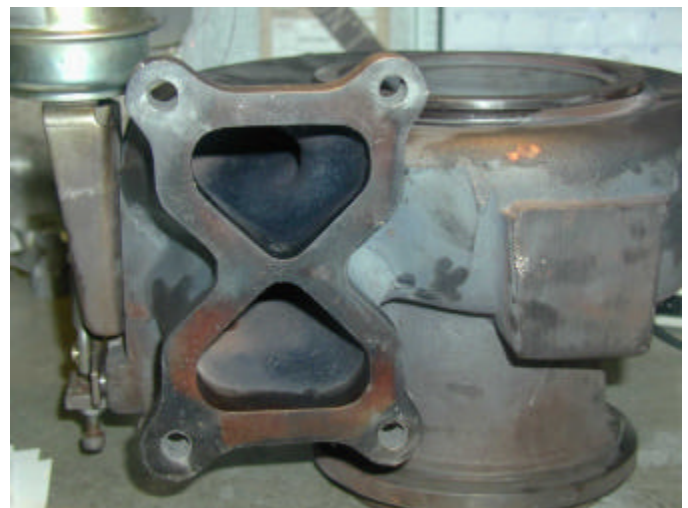
None of the new design units had any inlet flange cracking at the end of the testing. Figure 19 shows the inlet flange after 700 hours of testing. The 700-hour unit had a crack, which became slightly visible on the volute after 150 hours of testing and propagated further during the 700 hours test duration. The second 500-hour unit did not have such crack even after completing the 500 hours of testing. Figure 20 shows the volute after 500 hours of testing.

Figure 19: Inlet Flange of New Turbine Housing Design After 700 hours of Gas Stand Endurance Testing.

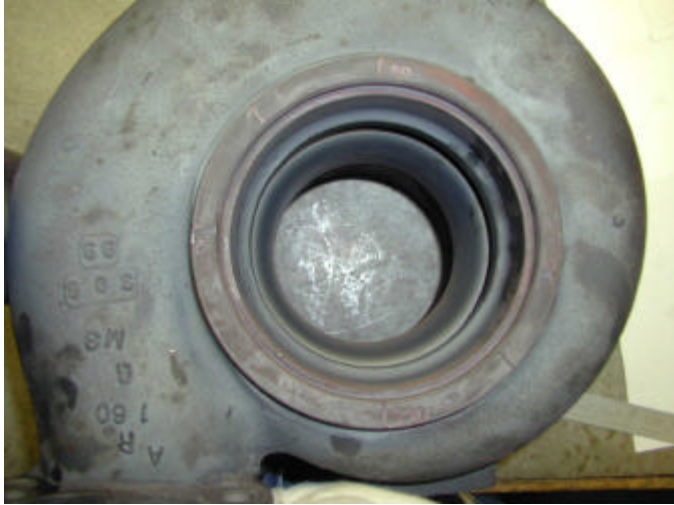
Figure 20: Volute of New Turbine Housing Design After 500 hours of Gas Stand Endurance Testing.

Internal radial relief cracking at the divider wall had started to develop on both units at about 100-200 hours of testing. However, no divider wall cracking at the inlet flange was observed for either of the new design units.
